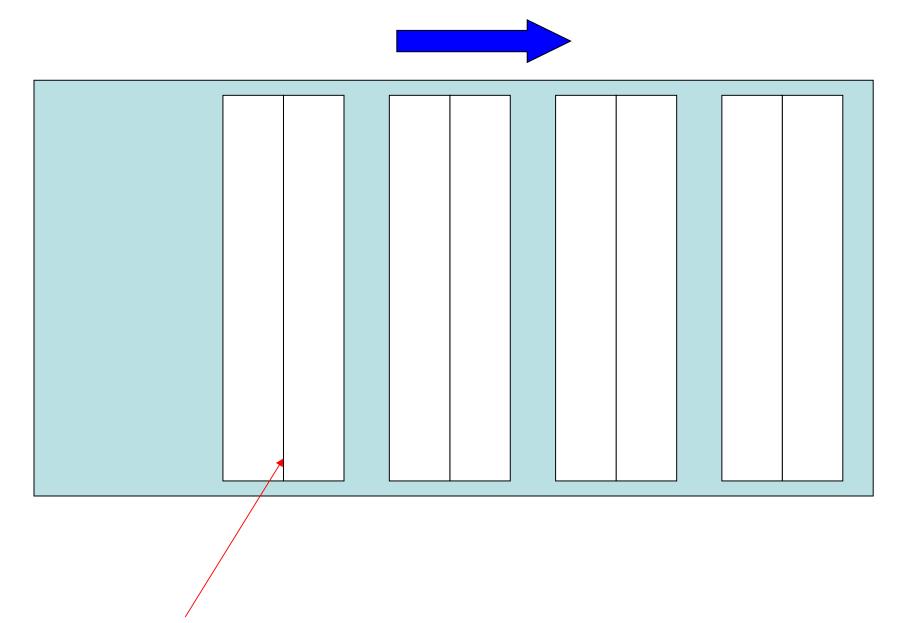
KISS-CUT: the top surface has been cut, but there is no gap between labels. When you remove the matrix during the manufacturing process, both labels keeps together and "seems like one" by the printer.
